SHROPSHIRE HISTORY AND ARCHAEOLOGY

TRANSACTIONS OF THE SHROPSHIRE ARCHAEOLOGICAL
AND HISTORICAL SOCIETY

VOLUME LXXXI 2006

MADELEY COURT, SHROPSHIRE:

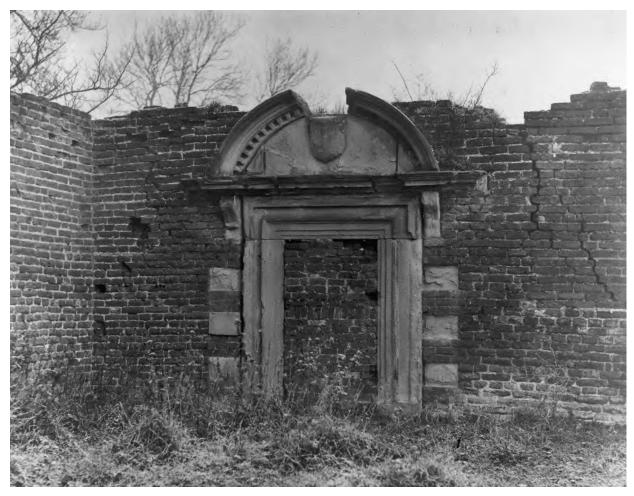
Plate VI Internal face of gateway in north wall of 17th-century garden, c.1900 (S. T. Walker Collection)

At the west ends of the north and south walls, and contemporary with them, are ornate stone doorways (Pl. VI, the northern example). The use of classical gateways in gardens was introduced into England by Jones at Arundel House between 1615 and 1619 (Strong, 1979, 171). The northern doorway is the better preserved (that to the south was heavily restored in 1989), and comprises a square-headed door surround, with shallow fluting and a segmental pediment above. Set within the pediment is a plain, raised shield. Above the door head is an architrave supported on a pair of brackets. On stylistic and comparative grounds a date of c.1620–40 is suggested (e.g. Gotch, 1901, 83, Pl. 22). Set in to the east side of the outside of the doorway are two iron hinge pins, suggesting that the garden door opened outwards. Unfortunately, as is the case with the south doorway, the exterior decorative doorway surround has been removed, leaving a void or scar. To either side of the north doorway are shallow brick piers, perhaps elements of a porch-like structure. Both doorways are blocked with bricks of the same type as those used in the wall and bonded with lime mortar. Until the mid-20th century there was a small, undecorated doorway in the north wall to the west of the house. This was originally mirrored by one in the south wall, and a door in that position, constructed of wooden planks, can be seen on a photograph of the early part of the 20th century (SA: PH/M/1/7, neg. B2622).

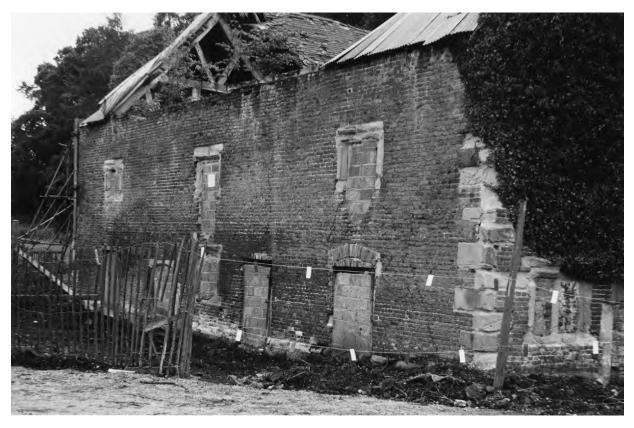
Plate I Madeley Court barn: north elevation in 1991.

The earliest masonry structure on the site was a T-shaped building with three floors. Its main east-west wing on the north side measured 20.05m. long externally and about 7.35m. wide above the offset plinth. Centrally placed on the south side of this was a smaller wing measuring about 7.40m. east-west externally by 6.95m. north-south, but there was no masonry division between the two spaces. It was built entirely of brick, with sandstone quoins, window and door dressings and plinth (Figs. 2, 3 8 and 9 and Plate I).

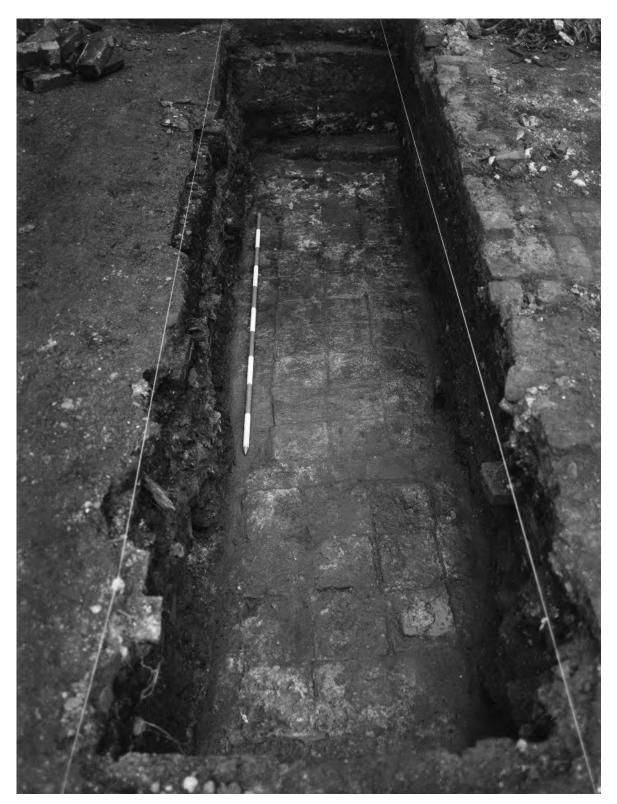
Plate VI Madeley Court barn: primary tiled floor in Trench 1, Part A.

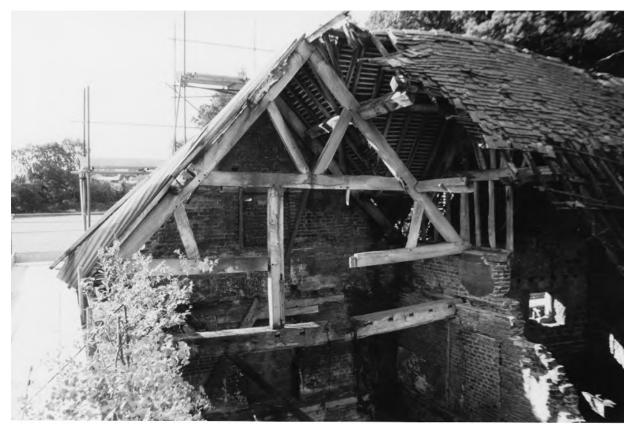
Plate VIII Madeley Court barn: Truss 2 prior to removal.

Of the original roof structure over the north wing, two intermediate trusses were recovered *in situ* and almost intact (Trusses 2 and 8, Figs. 11 and 12 and Plates VIII and IX); pieces of the two end trusses (Trusses 1 and 9) were recovered *in situ*, while fragments of a fifth truss (Truss 7) had fallen into the shell of the building, but were recovered. In addition, pieces of wall plate, upper and lower purlins, upper purlin braces and ridge pieces were also recovered. The roof was substantially intact in the early 1970s and Meeson's drawing (Fig. 13) and photographs (Plates X-XII) add substantially to the information about the form of the second, or attic, floor and roof.

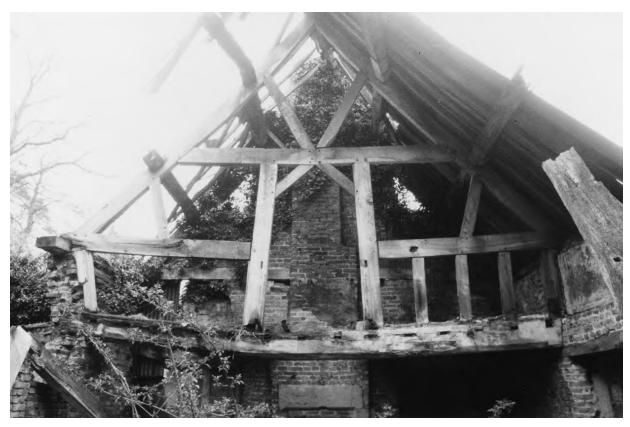
Plate IX Madeley Court barn: Truss 8 prior to removal.

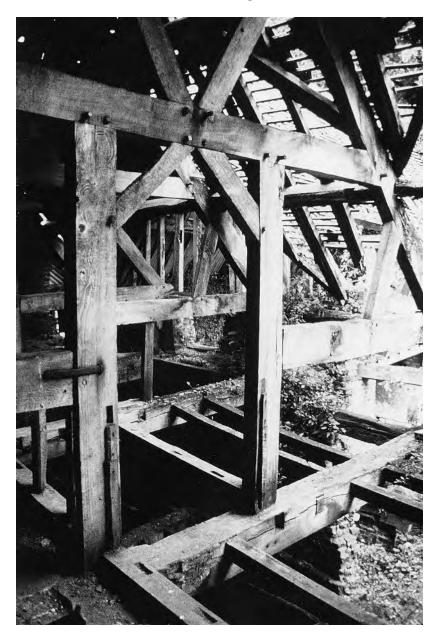
Plate XI Madeley Court barn: part of roof frame of north wing looking south-east prior to collapse (Bob Meeson).

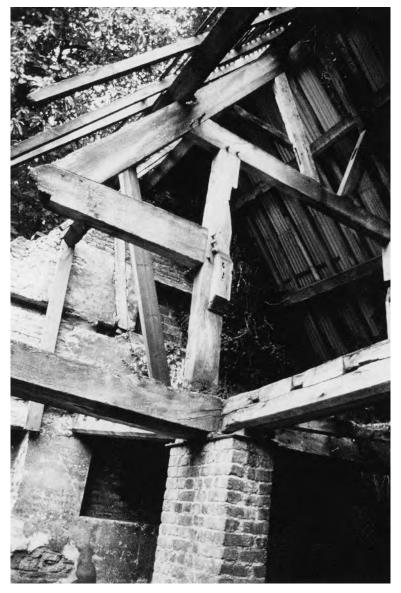
Plate XIII Madeley Court barn: roof and attic floor frame of south-west wing, including Truss 11, prior to collapse (Bob Meeson).

At second, or attic, floor level there was no trace of plaster on the walls that survived. There was a single window in the south gable. The floor had been carried on a main east-west beam, which also formed the tie beam of Truss 11 (Plate XIII), with girders and fourteen sets of joists. There were no remains of the truss set into the south gable, nor of that in the centre of the room, but some fragments of that which formed the north end of the roof were recovered (Truss 10, Plate XIV). This had been positioned immediately next to the wall-plate of the Phase 1 building, but was of insufficient length to span the full width of the space. It must have been made and inserted to accommodate the pre-existing roof over the original south wing. The tie beam had been cut to provide access into the space at a later date.

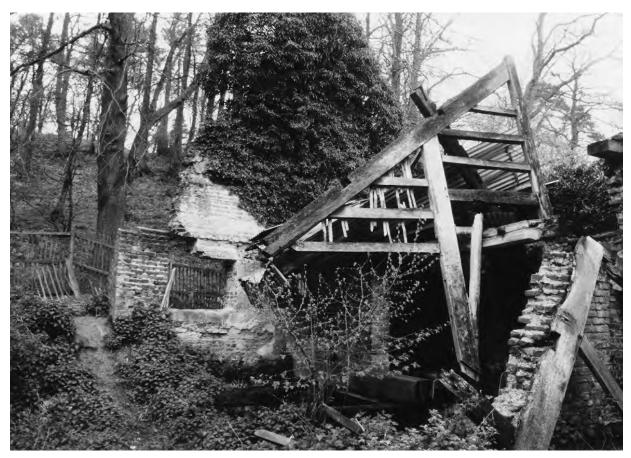
Plate XIV Madeley Court barn: Truss 10 in 1991.

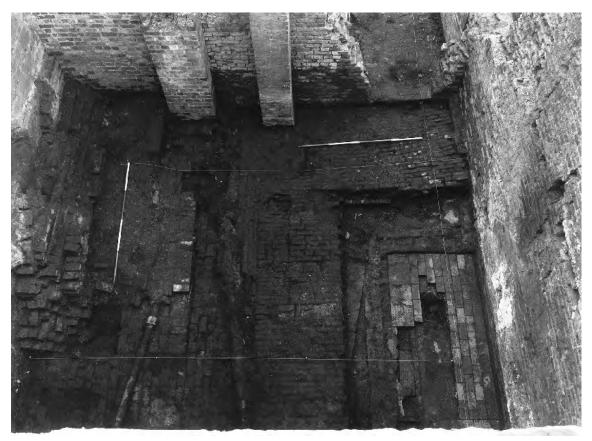
Plate XVII Madeley Court barn: detail of steeping tank during excavation.

The evidence of the standing building supports the results of the excavation in suggesting that the additions represented an enlargement of the maltings with additional floor space, a second kiln and a purpose-built steeping tank within the building. The suggestion in the excavation report that it might have been a stable seems unlikely as no evidence of an external door has been found, but the evidence is not conclusive.

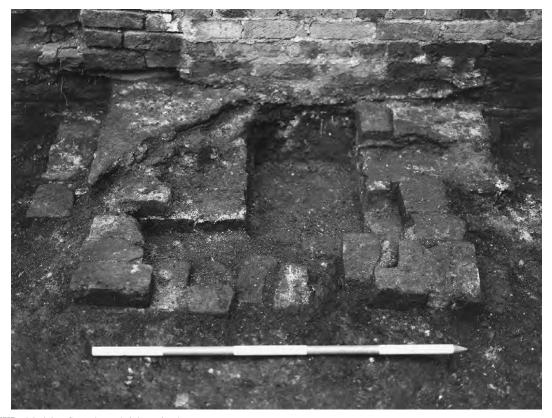
Plate XXI Madeley Court barn: brick engine base.

To summarise, in its third phase the building was converted for agricultural use. The north wing was divided into four parts by the insertion of walls, and excavations have demonstrated that brick floors and timber stalling were introduced to provide four stabling units, each with its own external door. The south-west addition might also have been used for stabling, while the remaining space on the south side accommodated a boiler and steam engine for an, as yet undetermined but presumably agricultural, purpose.

Malting appears to have been abandoned in the building before 1847 and, since it was mounted on a disused plateway weighbridge, the engine is likely to have been installed after the abandonment of the series of plateways created around the site after 1841. The Madeley Tithe Map, produced in 1847, shows a network of pits linked by minor railways, presumably plateways, and a 'tram road'. By the time the survey was undertaken for the first edition of the Ordnance Survey plan in 1882 the area was crossed by a series of railway lines, presumably of standard gauge, and plateways. These seem to have served the Madeley Court Colliery and the Iron Works. The chimney serving the engine appears to be shown on the 1882 plan, so the most likely date bracket for the insertion of the engine would seem to be between 1847 and 1882.

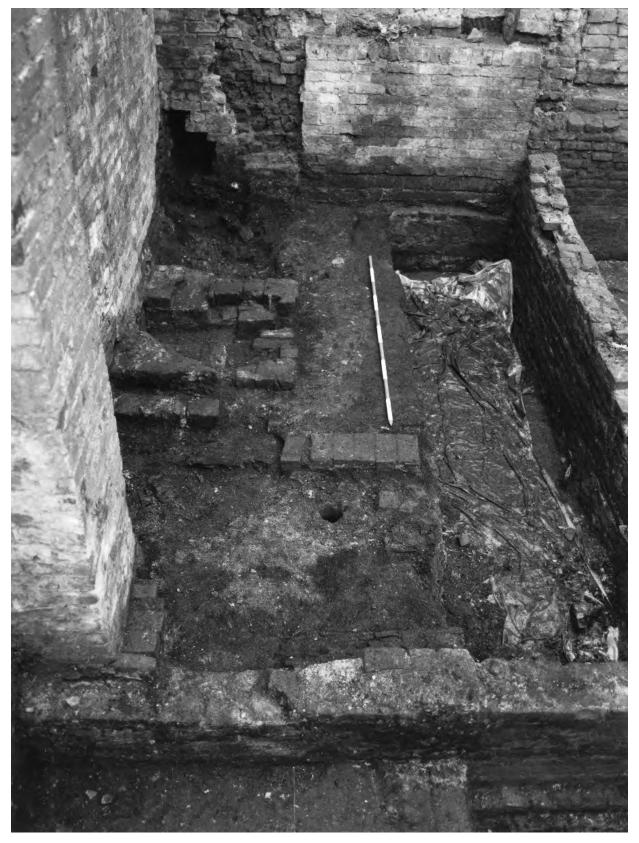
Plate XXII Madeley Court barn: brick engine base looking south.

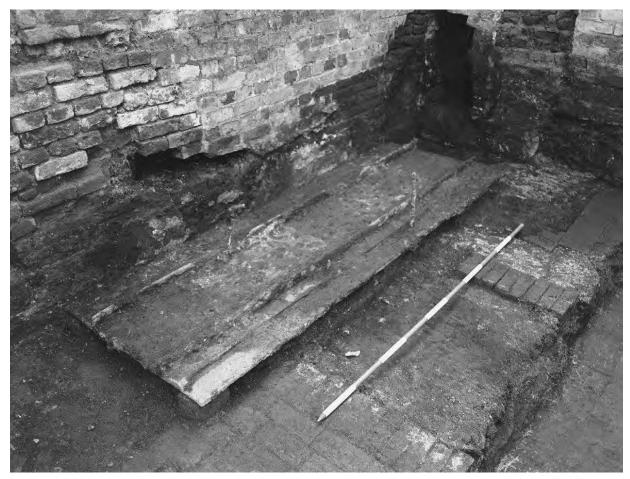
Plate XXIII Madeley Court barn: re-used plateway weighbridge.

Assuming that the secondary use of the plateway weighbridge occurred as the direct result of the abandonment of a section of plateway following construction of one of these two standard gauge railway lines, then this phase of conversion is likely to date to either the period 1854–1882 or to the period 1861–1882.

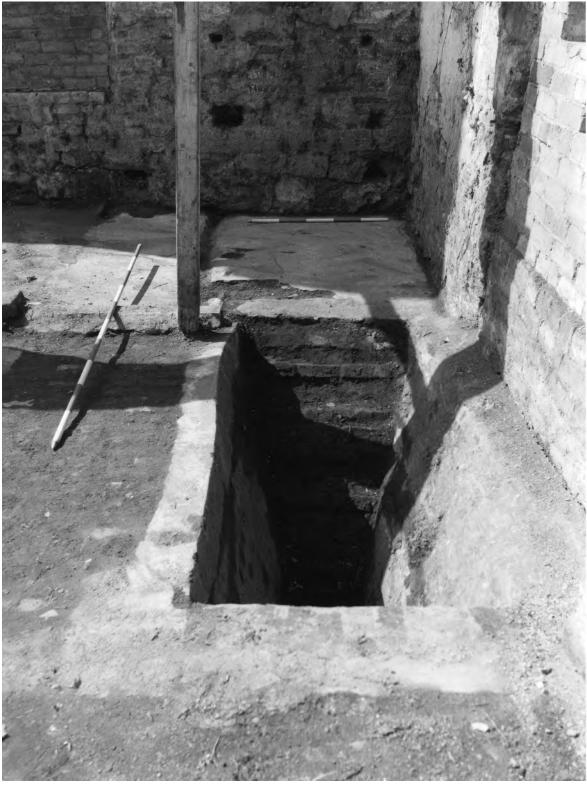
Plate XXIV Madeley Court barn: sheep dip in south-west extension.

During the lowering of the ground level around the building, the foundations of an extension were found at the south side of the south-west corner of the building, and there were rafter pockets in the brickwork on the south gable at first floor level which indicated the former existence of a timber roof. The remains comprised two courses of stone foundation, 800mm. and 550mm. wide, supporting several courses of brick wall, 400mm. thick, and measured approximately 7.30m. long by about 5.00m. wide externally (Fig. 3). Within its south-west angle there were remains of a brick floor with its upper surface at about 103.3m.O.D. To the east of the building was an old ground surface, at the same level as the floor, over brown clay, and both this and the remains of the building were buried under about 3m. of blue-grey clay. This structure is shown on the Madeley Tithe Map of 1847, but not on the Ordnance Survey plan of 1882, by which time quantities of clay had been extracted from the nearby coal and ironstone works, and deposited to the immediate south-west of the barn. It is safe to conclude, therefore, that the extension was erected before 1847 and demolished before 1882.
